ENGINEERING STUDY OF SELECTED LOCATIONS EXPERIENCING HIGH ACCIDENT FREQUENCY UNDER SNOWY AND ICY ROADWAY CONDITIONS

PREPARED BY
PROJECT PLANNING SECTION
PLANNING AND RESEARCH BUREAU
ENGINEERING DIVISION
MONTANA DEPT. OF HIGHWAYS

MONTANA DEPT. OF COMMUNITY AFFAIRS
HIGHWAY TRAFFIC SAFETY DIVISION

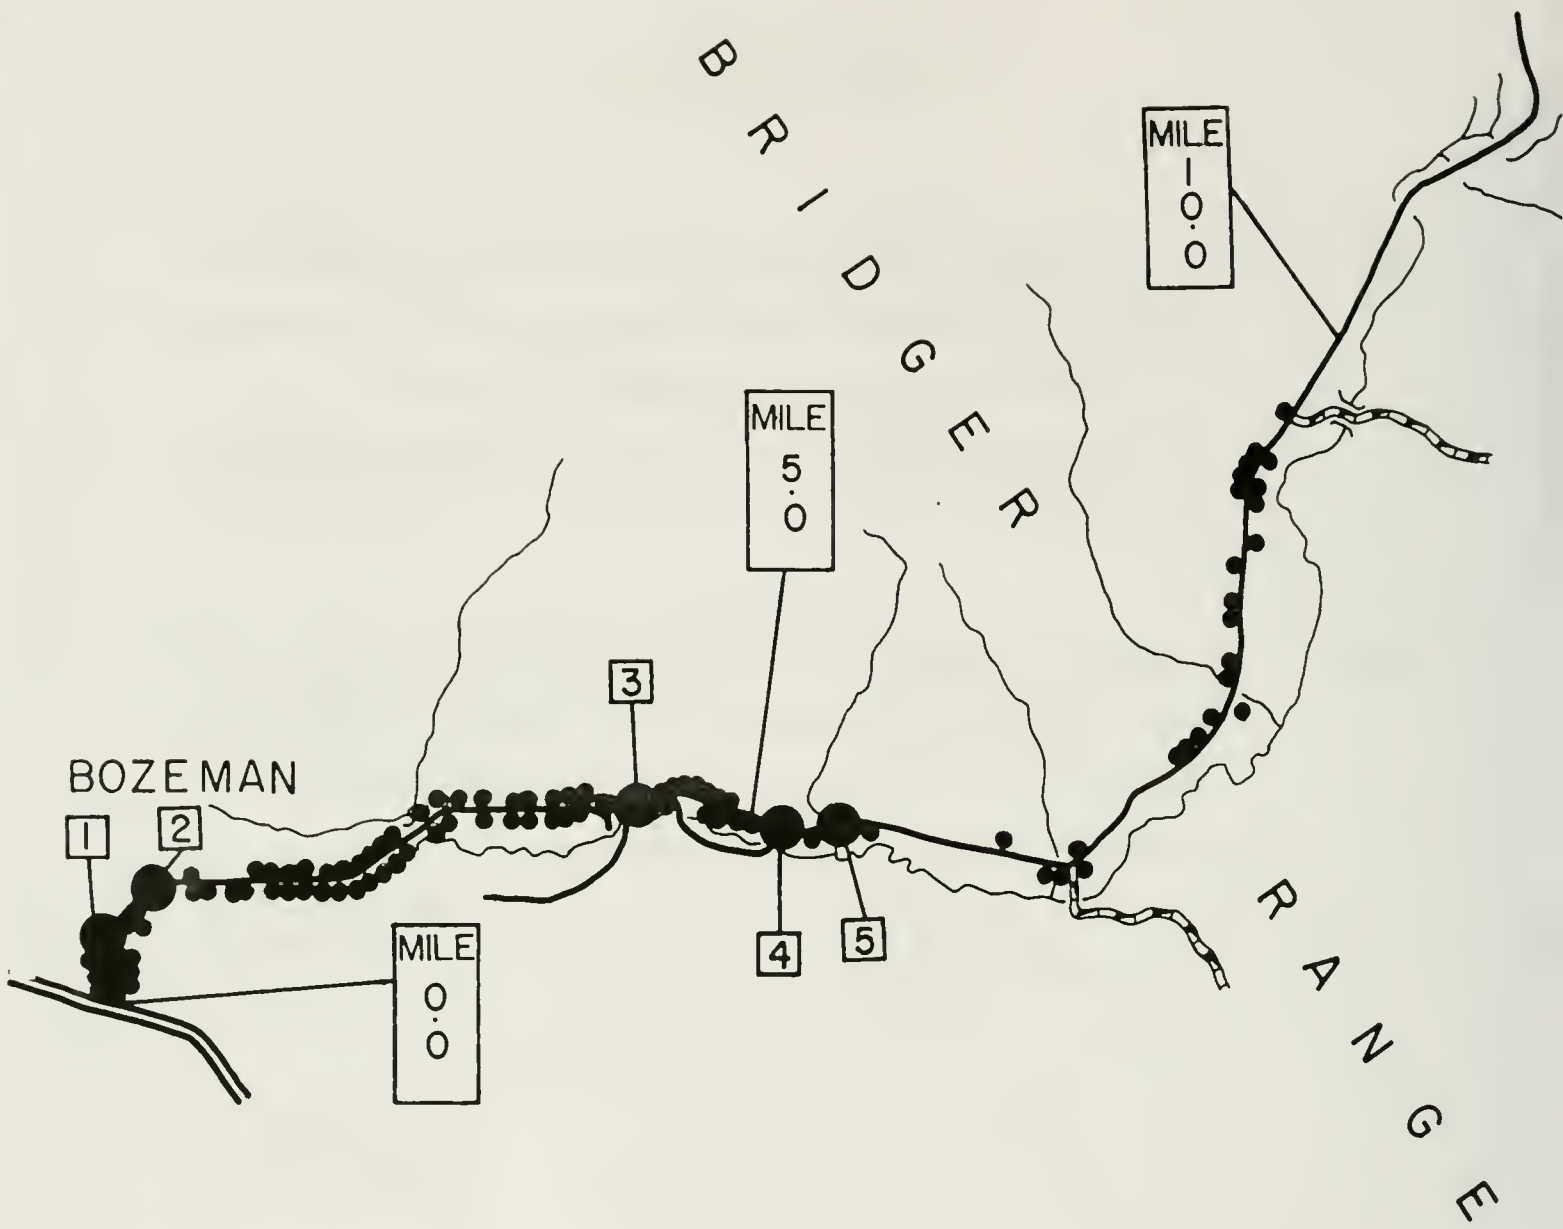
- MILEPOST 0 - MILEPOST 10
 - ACCIDENT CLUSTER SITES
 - INDIVIDUAL ACCIDENTS
- Scale: 1 inch = 1 mile

General: This study section begins in downtown Bozeman and extends northeasterly through the Bridger Canyon. This roadway is heavily used during the winter months providing access to winter sport areas. The roadway includes a detour section due to a slide condition. The roadway varies in width depending on different construct projects, however, the roadway is a two-lane plant mix surface facility.

Comment: Heavy concentrations of accidents is evident in the first 5+ miles of the section. This can be attributed to, in part, high traffic volumes, intersections and uncontrolled access. A cluster of accidents is identified at the intersection of Mont. 86 and Griffin Drive. A safety project to alter the geometrics of this intersection is planned. A preliminary engineering program for the correction of the slide area at milepost 5+ is also in force. A horizontal curve at Milepost 8.8 - 9.3 has been identified as a high accident rate cluster area and improved advanced warning is planned.
